# Protox Handbook

Identification, control  
and prevention of fungal, mould  
and insect infestations

**PROTOX**

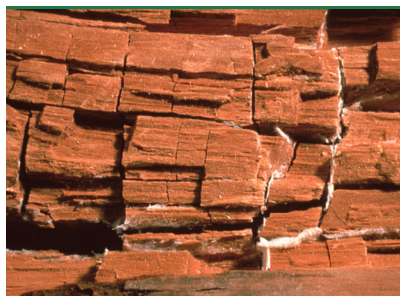
Brown rot - the fungus breaks down the cellulose fibres, leaving the lignin.

Refers to various forms of decomposition caused by wood-breaking fungi. The 3 main components of wood are cellulose, lignin and hemicellulose. Cellulose, which is made up of long twisted fibres, has the function of creating the breaking strength of the wood. A bit like how you give breaking strength in concrete by casting an iron net. When the wood-degrading fungus degrades the cellulose fibres, the breaking strength is removed and this degradation is called brown rot. In the case of brown rot, the wood turns brown and cracks in blocks along and across the grain (grain direction). Examples of brown mould-forming fungi are dry rot fungus, wet rot fungus, mine fungus, gilled polypore and tapinella.

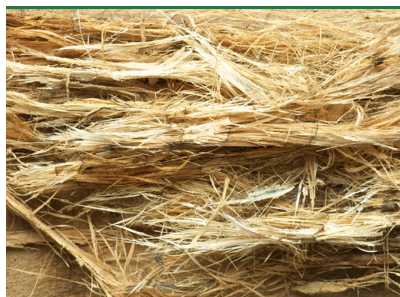
White rot - the fungus breaks down the lignin in the wood, leaving the cellulose threads. This frays the wood.

Lignin, on the other hand, is the "filler" of wood - like the cement in a concrete casting. If the wood-degrading fungus breaks down the lignin in the wood, the cellulose threads will remain as distinct wood fibres. This decomposition is called white rot. With white rot, the wood is frayed and soft, and it does not crack. Softwoods do not change colour, darker hardwoods become bleached. White rot fungi include bark fungi and aspen bracket fungi.

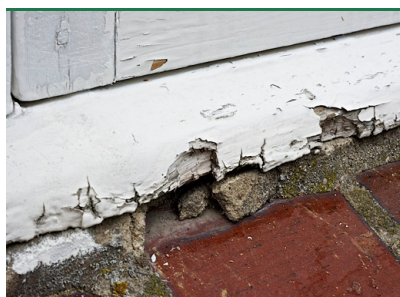
Grey rot (Surface rot) - dripping on old window.

With grey rot (surface rot), the wood turns grey and loses weight, but retains its shape. Wet wood can be compressed; but regains its shape when the pressure is relieved. In case of severe drying, small cracks are formed. Grey rot is caused by special fungi which, when decomposing, form tunnels inside the cell walls of the wood.

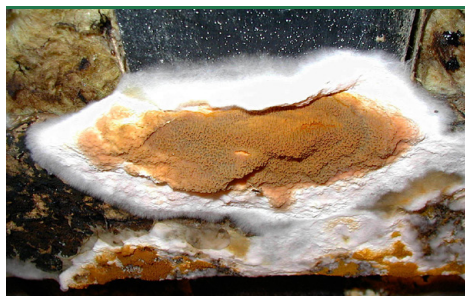
svn 1 Dry rot fungus - fruiting body.  
(Photo: Bøgh & Helstrup)

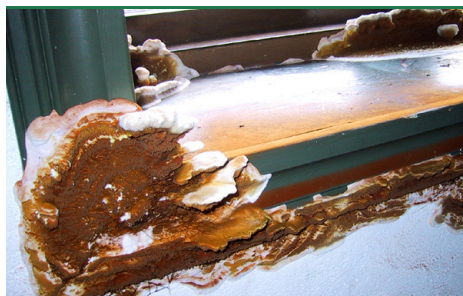
svn 2 Dry rot fungus - fruiting body in window sill  
of summer house. (Photo: Protox)

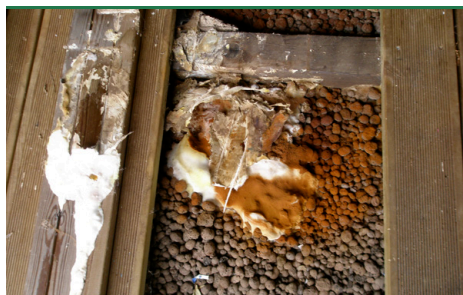
svn 4 Dry rot fungus - fruiting body, cocoa-like spore  
powder and mycelium on Leca under floor in  
conservatory. (Photo: Protox/customer photo)

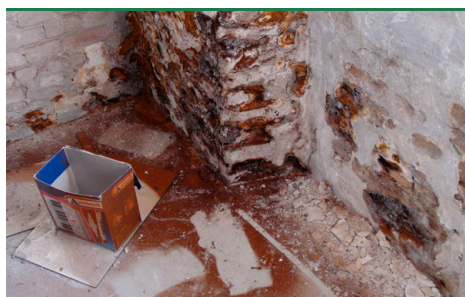
svn 5 Dry rot fungus - reddish-brown spore powder  
on the floor. (Photo: Protox)

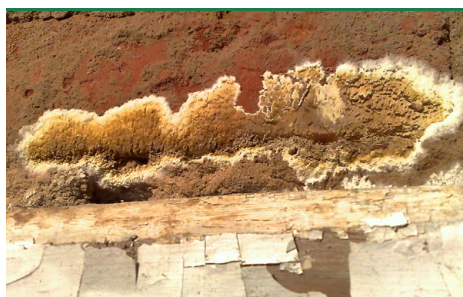
svn 6 Wet rot fungus - fruiting body on brick.  
(Photo: Goritas)

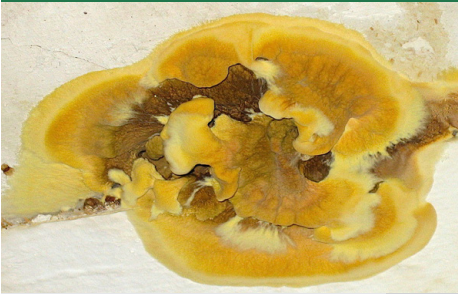
svn  
7

Wet rot fungus - fruiting body.  
(Photo: Goritas)

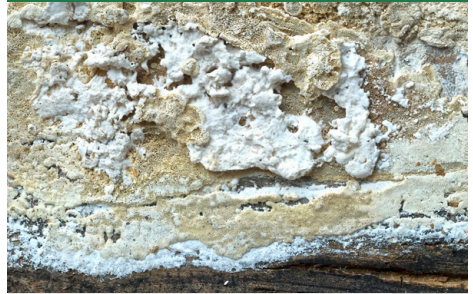
svn  
8

Mine fungus - fruiting body.  
(Photo: Protox/Goritas)

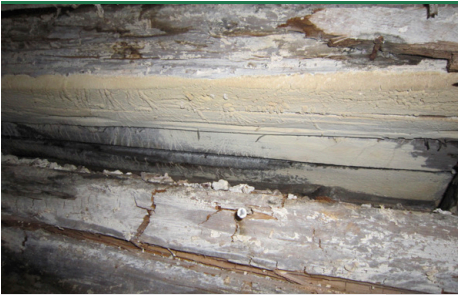
svn  
9

Mine fungus - fruiting bodies and  
mycelium on decayed wood with crevices.  
(Photo: Bøgh & Helstrup)

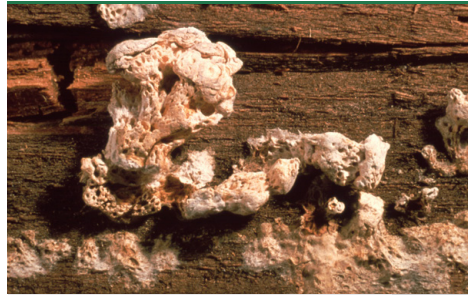
svn  
10

Serried crust fungus - sterile, cauliflower-like  
fruiting bodies growing in the dark.  
(Photo: Protox/Gori)

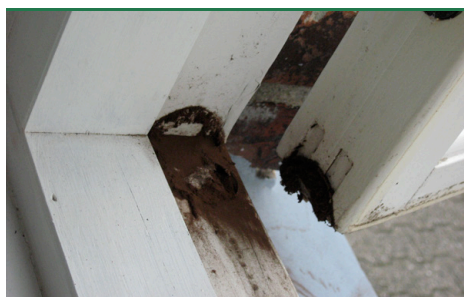
svn  
23

Slime mould - mature, broken fruiting body with spore powder. (Photo: Protox)

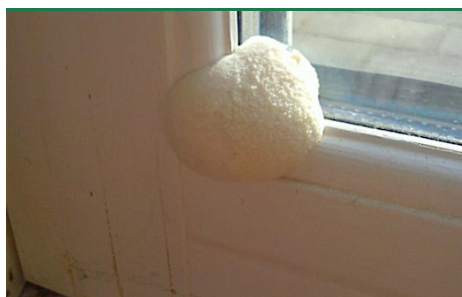
svn  
24

Slime mould - young fruiting body in door. (Photo: Protox)

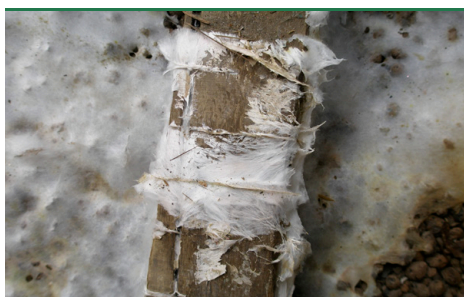
svn  
27 Dry rot fungus - young mycelium with string formations, slatted in conservatory. (Photo: Protox)

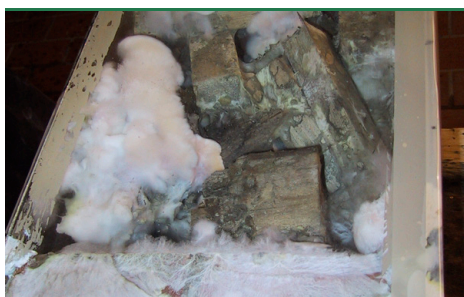
svn  
29 Dry rot fungus - young surface mycelium, 2 weeks. (Photo: Protox)

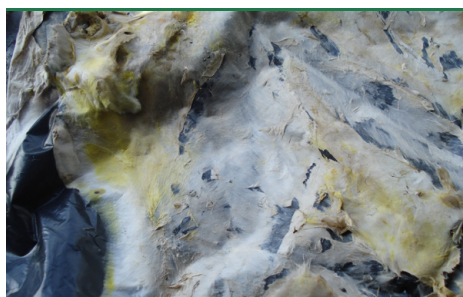
svn  
30 Dry rot fungus - surface mycelium with characteristic yellow spots. (Photo - Protox)

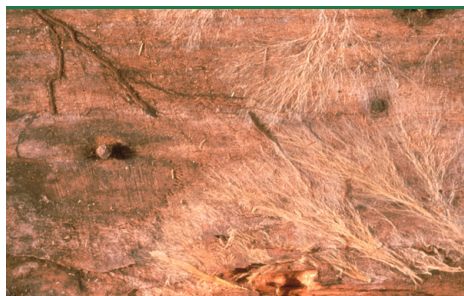
svn  
31

Wet rot fungus - characteristic dark and light string mycelium. (Photo: Protox/Gori)

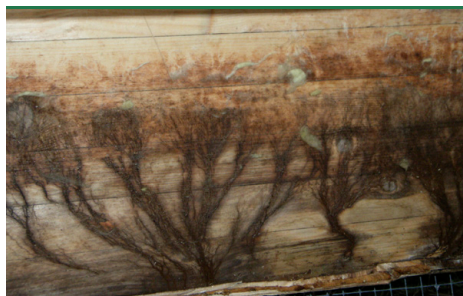
svn  
32

Wet rot fungus - brown stringy mycelium on glulam beam. (Photo: Protox)

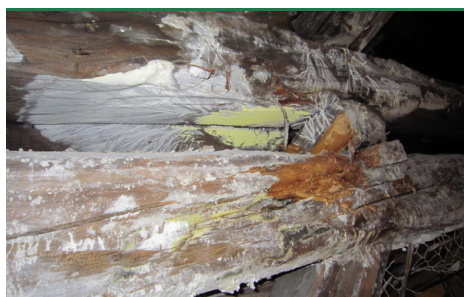
svn  
33

Mine fungus - attack in roof construction. Cal-careous fruiting bodies, young, white mycelium and flexible strands. (Photo: Bøgh & Helstrup)

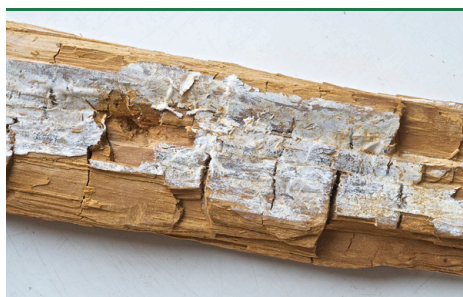
svn  
34

Mine fungus - white surface mycelium on decomposed wood with fissure blocks. (Photo: Protox/Goritas)

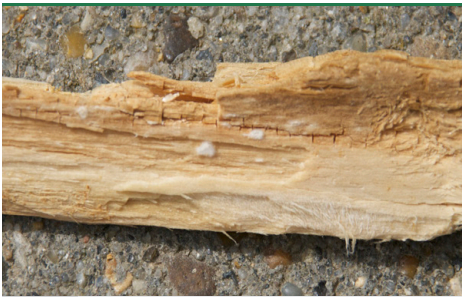
svn 39 Gilled polypore in outer covering. Note small tufts of surface mycelium on fracture surfaces (Photo: Protox)

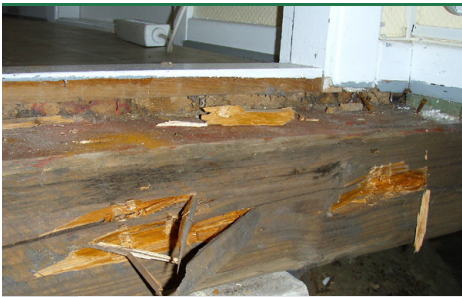
svn 41 Bark fungus – Star hair Bark fungus on wood in basement. (Photo: Protox/Goritas)

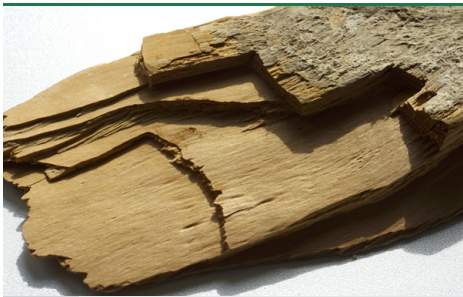
svn 42 Wet rot fungus – brown rot, leaf decomposition. Assessed as fungal damage. (Photo: Protox/Goritas)

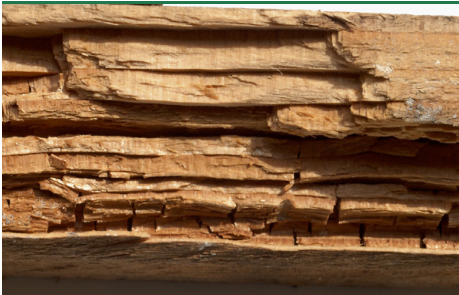
svn  
43

Serried crust fungus (Mine fungus)  
- decomposition. (Photo: Protox)

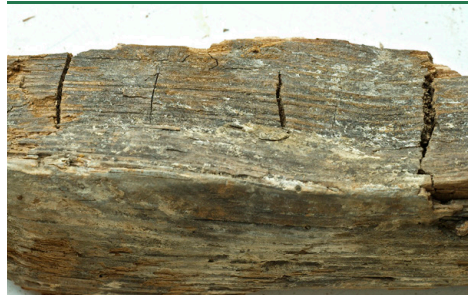
svn  
44

Dry rot fungus - old attack. Weak mycelial  
remains and clear transverse fissures.  
(Photo: Protox/Goritas)

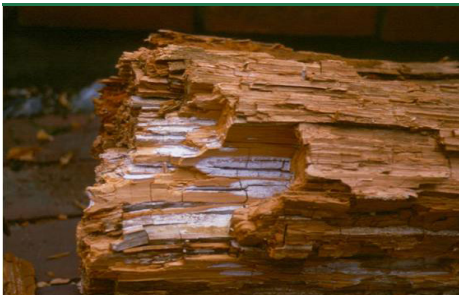
svn  
45

Mine fungus - decomposition and white  
surface mycelium on fracture surfaces.  
(Photo: Goritas)

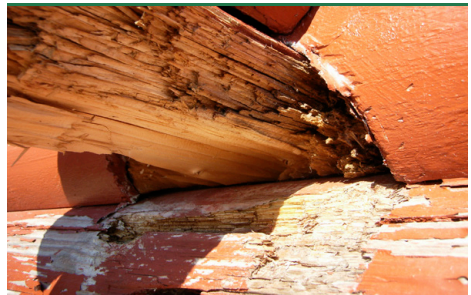
svn  
46

Gilled polypore - decomposition in a log  
house. (Photo: Protox)

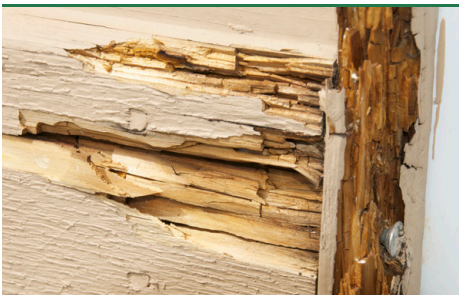
svn  
47

Gilled polypore - degradation in wooden clad-  
ding in holiday homes. Attack 3-4 years old.  
(Photo: Protox)

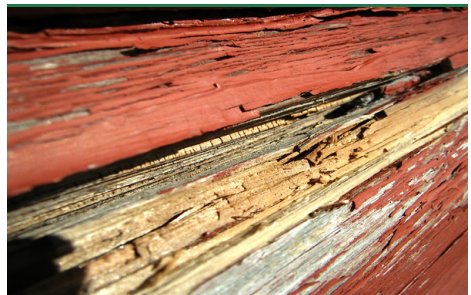
svn  
48

Gilled polypore - leaf decomposition in log  
house. (Photo: Protox)

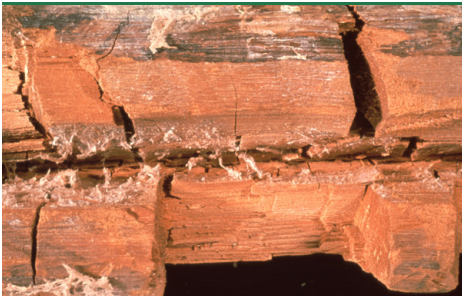
svn 49  
Dry rot fungus - broken down wooden beam. Brown rot with large fissure blocks and surface mycelium. (Photo: Protox/Gori)

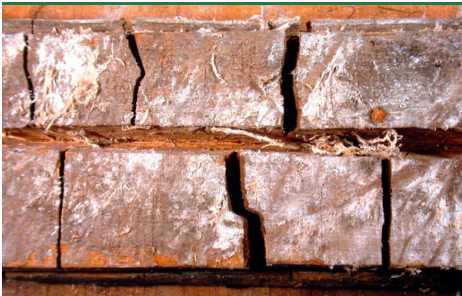
svn 50  
Dry rot fungus- crevice blocks. (Photo: Hussvamp Laboratoriet)

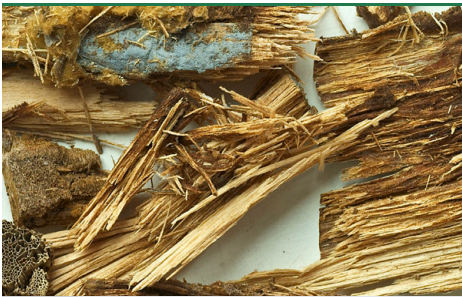
svn 51  
Cohesive aspen bracket fungus - stringy decomposition and blue-green coating is a mould attack. (Photo: Protox/Goritas)

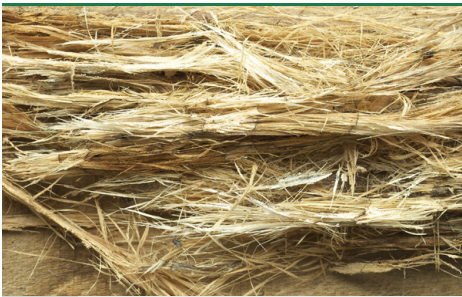
svn 52  
White rot decomposition - unknown fungus. (Photo: Protox)

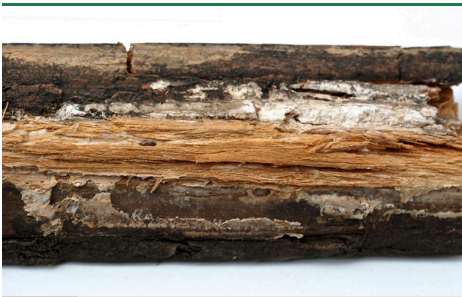
svn 53  
Bark fungus in window frame (white rot). (Photo: Goritas)

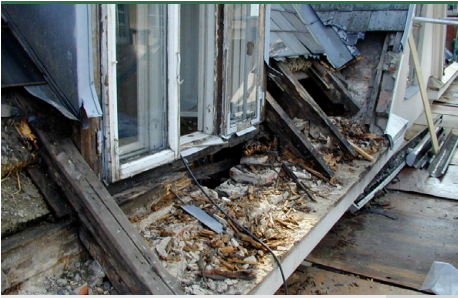
svn  
55

General advice – eaves broken down.  
(Photo: Tryg Forsikring)

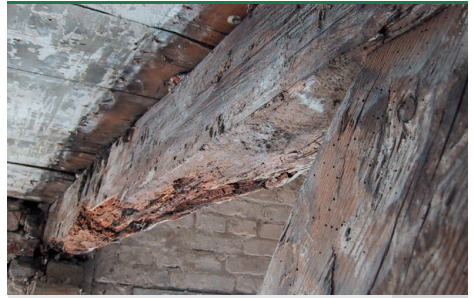
svn  
56

Common advice in exposed ceiling beams.  
(Photo: Prottox)

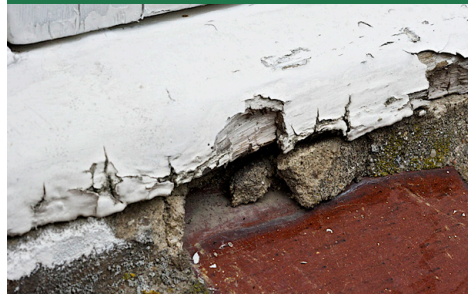
svn  
58

Surface rot (grey rot) – dripping on old  
window. (Photo: Prottox)

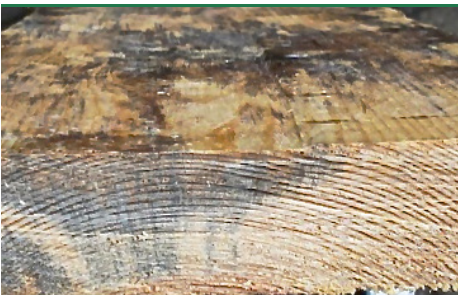
svn  
59

Blue stain fungus – attacked softwood in pith  
rays from the surface to the core of the tree.  
(Photo: Prottox)

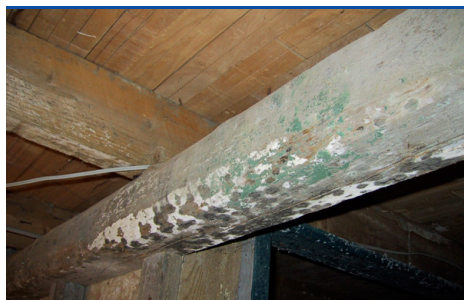
skn  
1

Mould growth (*Trichoderma* sp.) on a water-damaged beam in the basement. (Photo: Protox)

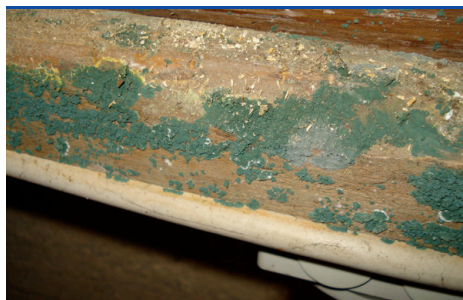
skn  
2

Mould growth (*Trichoderma* sp.) on formwork board in water-damaged crawl space. (Photo: Protox)

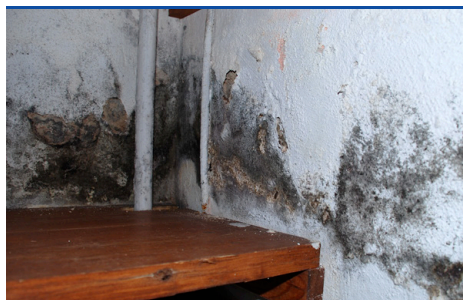
skn  
6

Black mould on moisture-laden basement foundation. (Photo: Protox)

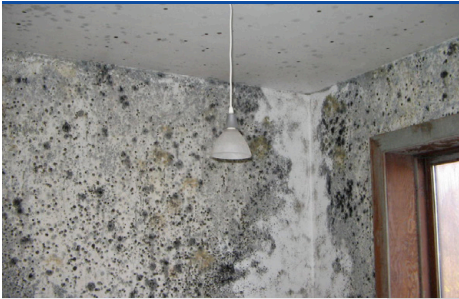
skn  
7

Mould growth in living room after water damage. (Photo: Protox/customer photo)

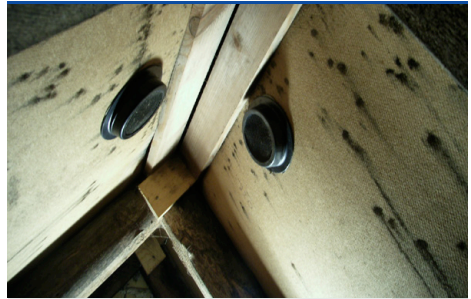
skn  
8

Black mould on the roof due to lack of ventilation of the roof space (valves retrofitted). (Photo: Protox)

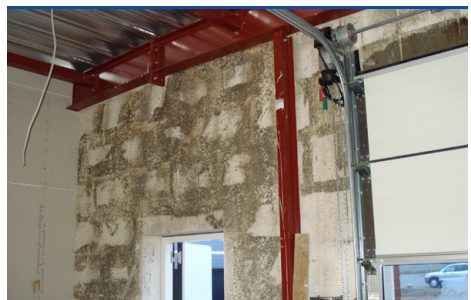
skn  
12

Mould growth on a newly built wall in an industrial hall as a result of construction moisture. (Photo: Protox)

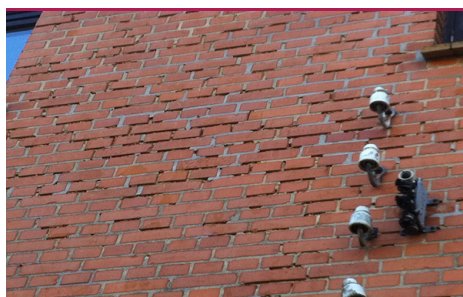
in  
23

Plasterer bees - joints in masonry partially broken down. (Photo: Protox)

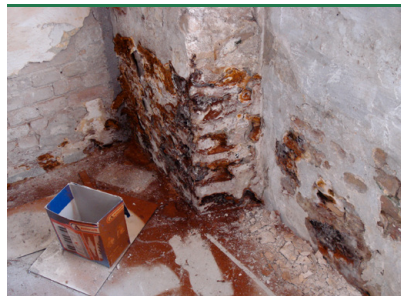
sv  
4

Dry rot fungus - spore powder on floor (from fruiting bodies on wall).  
(Photo: Protax)

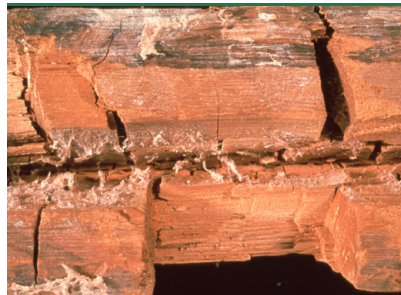
sv  
5

Dry rot fungus- crevice blocks.  
(Photo: Protax/Gori)

During decomposition, the wood loses most of its weight and it cracks across the fibre direction (brown rot, [see page 5](#)) with 5-10 cm large crack blocks as a result, often mixed with greyish mycelium and strings. Both splinter and core break down.

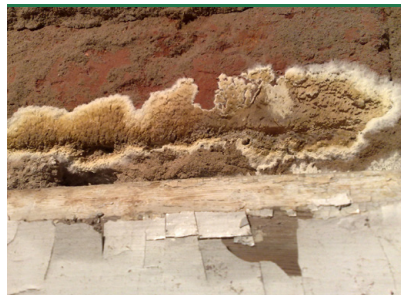
sv  
6

Wet rot fungus - fruiting body.  
(Photo: Goritas)

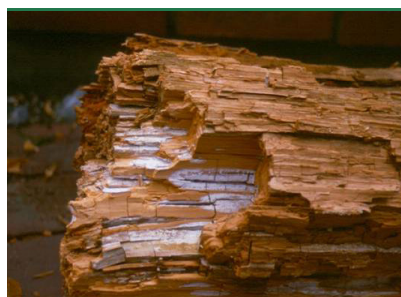
sv  
12

Mine fungus – crack bricks. (Photo: Goritas)

Brown rot is formed (see page 5) with strong fissure blocks of 3-5 cm.

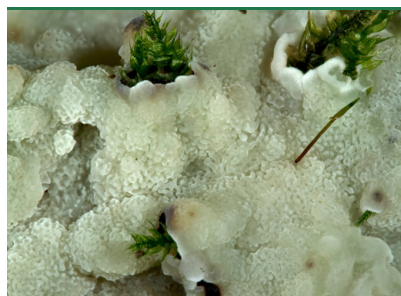
sv  
27

Crust fungus - Fruiting body.  
(Photo: Frank Abrahamsson from  
fugleognatur.dk)

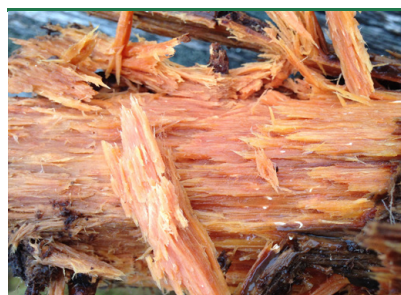
sv  
28

Crust fungus -Decayed wood.  
(Photo: Protox)

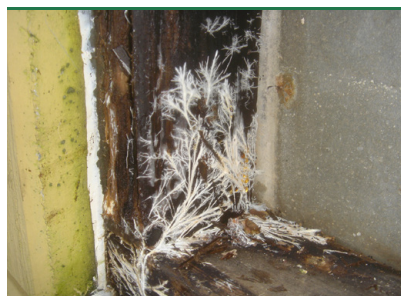
sv  
31

Bark fungus in frame wood.  
(Photo: Goritas)

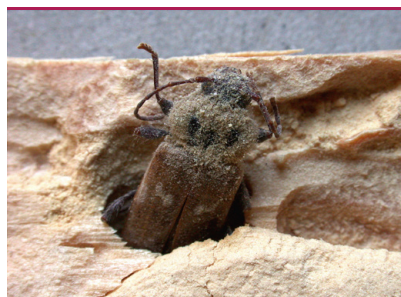
i  
4

House longhorn beetle – adult insect.  
(Photo: Hussvamp Laboratoriet)

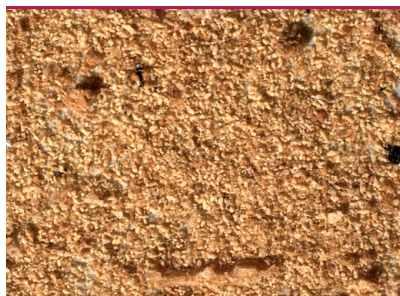
i  
22

*Hadrobregmus pertinax* – frass.  
(Photo: Protox/Goritas)

An attack by *Hadrobregmus pertinax* is a sign that the attacked woodwork is already attacked by rot, a replacement must therefore be considered.

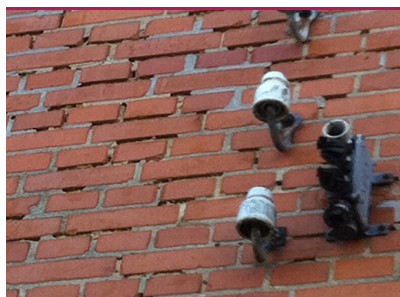
i  
34

Plasterer bee – broken joints in brick gable. (Photo: Prottox)

The repair itself should be carried out outside the bees' flight time, and in enough time that the mortar has a minimum of 1 month to harden, as the bees will be able to make new holes in not fully hardened mortar. If the repair must necessarily take place during the bees' flight time, it will be necessary to kill the bees with a suitable insecticide.

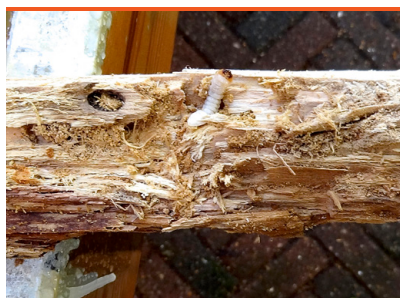
k  
6

Decayed wood with insect infestation
